Manhole Inspection Summary

Manhole # S29Q__009MH

Insp Date: **11/6/08 8:19 AM**

Location Address: **1204 Ridgely**

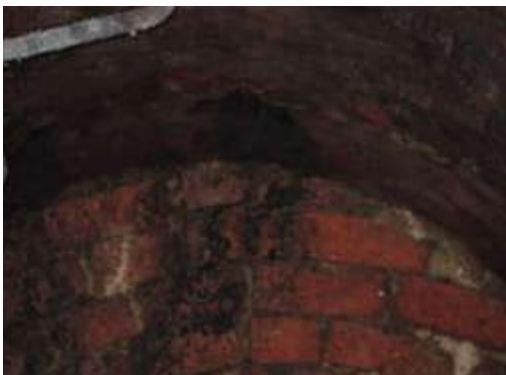
Defect 4

Infiltration: ☐ None ☐ Joint ☐ Cracks ☐ Mortar ☐ Roots ☒ **Wall**

infiltration in barrel

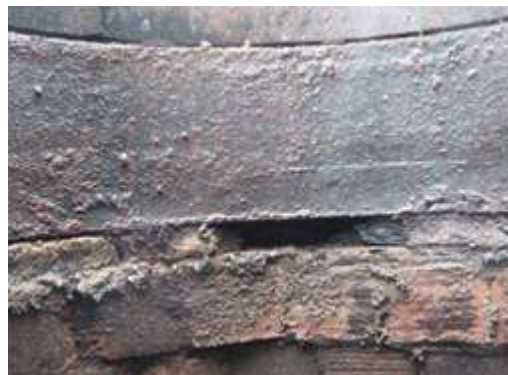
Defect 3

Condition: ☐ Sound ☐ Cracked ☐ Root Intrusion ☐ Loose Brick ☒ **Deteriorated**

Infiltration: ☐ None ☐ Joint ☐ Cracks ☐ Mortar ☐ Roots ☒ **Wall**

deterioration and infiltration under chimney

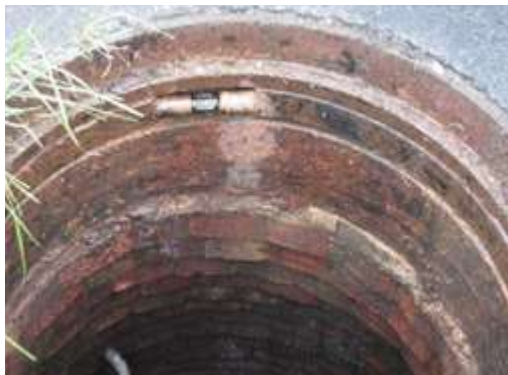
Defect 2

☒ **Cracked**

☒ **Leaks**

cracked and leaking frame

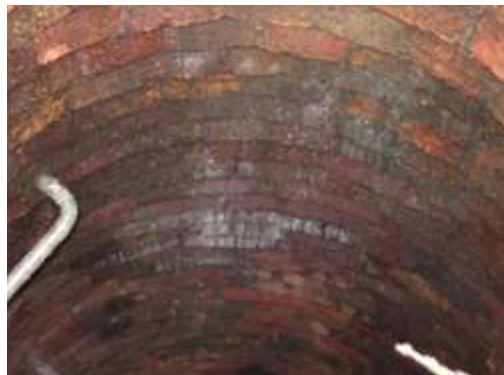
Defect 1

Infiltration: ☐ None ☐ Joint ☐ Cracks ☐ Mortar ☐ Roots ☒ **Wall**

infiltration along corbel wall

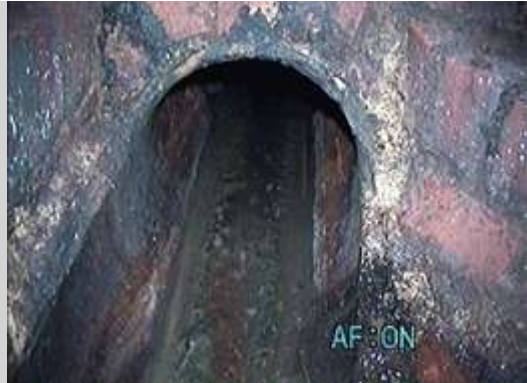
12 O'Clock Outflow

Pipe Height: **10.8** (in.) Rod and Bar (Angled)
Pipe Material: **Clay** ☐ Pipe Lined
Invert Depth: **10.78** (ft.) Flow Characteristics: **Slow**
Deposits: ☒ None ☐ Mud ☐ Sludge ☐ Debris ☐ Grease
Silt Depth: **0** (in.) Deposits Extent:
Infiltration: **None** Pipe Seal Cond: **Sound**

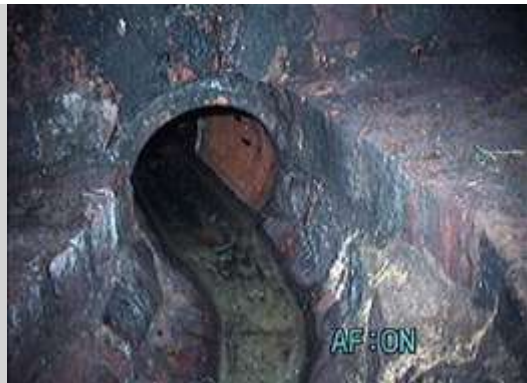
4 O'Clock Inflow

Pipe Height: **10.8** (in.) Rod and Bar (Angled)
Pipe Material: **Clay** ☐ Pipe Lined
Invert Depth: **10.59** (ft.) Flow Characteristics: **Slow**
Deposits: ☒ None ☐ Mud ☐ Sludge ☐ Debris ☐ Grease
Silt Depth: **0** (in.) Deposits Extent:
Infiltration: **None** Pipe Seal Cond: **Sound**
